3**AMIGA**

ISSUE 29 - APR-MAY-JUN 90

SECTION 3 - AMIGA

-
- 29/3-0.0 INDEX - AMIGA SECTION TECHTOPICS ISSUE 29.
 - 29/3-1.1 A2091 MEMORY AUTO-CONFIGURATION LIMITATIONS.
 - 29/3-2.1 A2091 IC MEMORY 262,144 ADDRESS X 4 BIT DRAM.

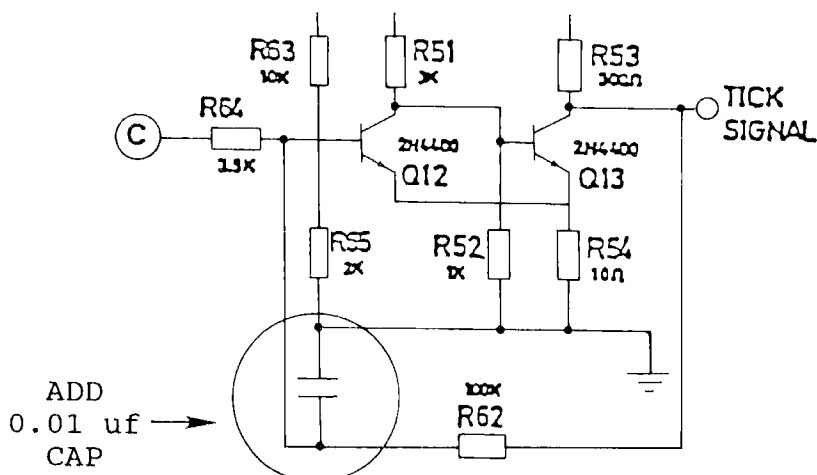
A2000 SYSTEM CLOCK FIX DIAGRAM

A WARRANTY LABOR RATE OF \$20.00 WILL BE CREDITED FOR THE FOLLOWING FIX ON THE ELTEK TYPE POWER SUPPLY TO CORRECT NOISE ON TICK SIGNAL. NOTE, A WHITE '00' STICKER IS ON POWER SUPPLIES WHICH HAVE THE MODIFICATION INSTALLED.

REFER TO ATTACHEMENT, ELTEK POWER SUPPLY SCHEMATIC. CHECK PIN 14 (TICK SIGNAL) OF CN400 WITH SCOPE FOR NOISE. ADD, ON POWER SUPPLY, 0.01 UF CAPACITOR BETWEEN R65 (GND SIDE), AND R62, AS INDICATED IN DETAIL DIAGRAM BELOW.
